**FINAL INVESTIGATION REPORT ON ACCIDENT TO M/S CHIMES
AVIATION ACADEMY PVT LTD. CESSNA-172 VT-CAI IN BARGI DAM,
JABALPUR ON 06.04.2009.**

1. Aircraft	Type	Cessna-172
	Nationality	Indian
	Registration	VT-CAI
2 Owner/Operator		Chimes Aviation Academy Pvt. Ltd
3 Pilot – in –Command		Student Pilot
	SPL No	CAA/D/133
	Extent of injuries	Fatal
4 Co-Pilot		N/A
	CPL No	N/A
	Extent of injuries	N/A
5 No. of Passengers on board		Nil
	Extent of Injuries	N/A
6 Last point of Departure		Dhana Airstrip
7 Intended landing place		Dhana Airstrip
8 Type of operation		Solo Cross-country flight
9 Place of Accident		Bargi Dam, Jabalpur 22deg 50’N 79deg 58’E
10 Date & Time of Accident		06/04/2009; 1100 UTC Approx

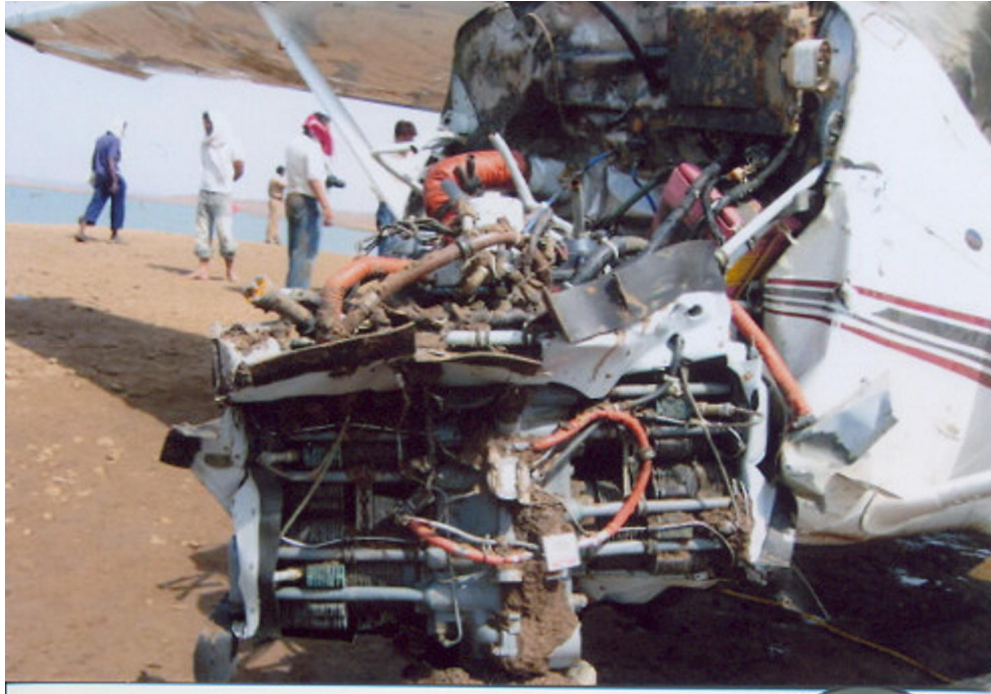
COMPLETELY DAMAGED AIRFRAME AND ENGINE

- The engine mount was broken and engine was tilted down.
- The propeller blades were found twisted & bend.
- The Nose landing gear was missing.
- Engine cowlings were missing & firewall yielded inward to cabin.
- There was distinct black sooth deposit on the top half portion of the firewall.
- Lower instrument panel found buckled with engine controls intact. The position of throttle was full in and mixture was one inch out to lean position.
- Centre console found distorted with parking brake assembly broken. The Fuel Selector Valve (FSV) was found selected in BOTH position.
- The flap motor position was checked to identify the position of the flap and was found in retracted position.
- Seat head rest found bend.
- There was no post impact fire as the aircraft went in the water body.

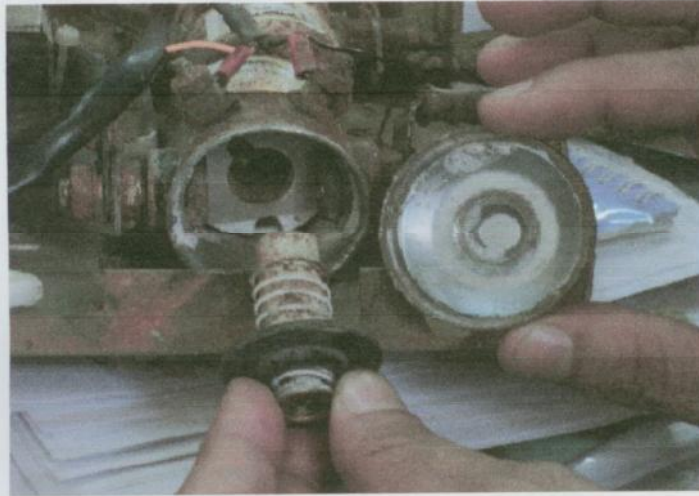
- a) Contactor P/N X61-0027 was supplied with 20 & 24 VDC; the click sound of relay operation was heard but the contact remained open and found to be with resistance of 180 K Ohms. After opening the contactor, it was observed that the solenoid plunger and spring found corroded due to water ingress. The resistance between blackened internal contact of the terminal and the plunger plate is high. This indicates the faulty contactor.
- b) Contactor P/N X61-0007 (3 Nos) were supplied with 24VDC; the operations was found satisfactory and the contact resistance was 0.10 Ohms. The solenoid coil resistance was found approximately 64 Ohms

The above indicate that the Contactor X61-0027 remained in closed condition thereby causing the contacts to burnout and making it open circuit.

- 4.1 All the Cessna 172R flying in country replacing the Starter with 149NL/ec manufactured by M/s Skytech should check for the X61-0027 relay whether it is available on their aircraft. One time inspection to be carried out and report submitted to DGCA.
- 4.2 The matter should be taken with the manufacturer for the contactor X 61-0027 modification for higher Ampere rating or restrict the life of the Contactor in view of failure.
- 4.3 The advisory to be issued to exercise abundant precaution during installation of starter as any misalignment could cause starter armature to become stiff and draw more current.

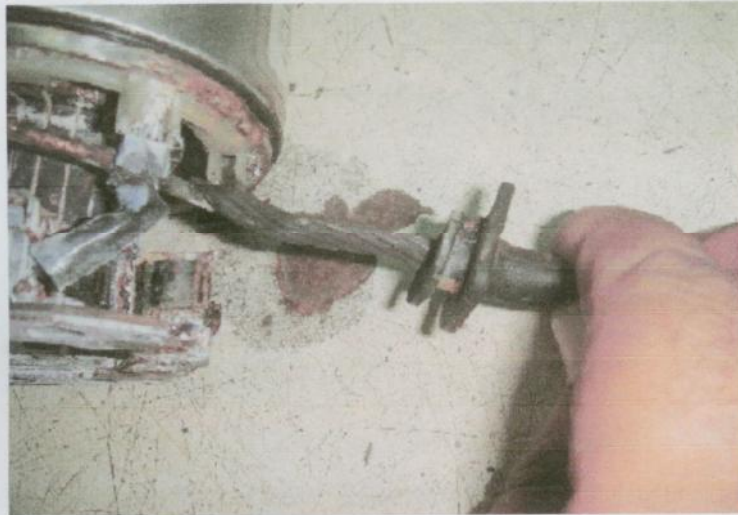
The Starter operational check without load was carried out at 24 VDC the solenoid operated and pushed the meshing gear forward however it did not start even at 19 Amp. The unit was jammed and not rotating with hand. The burnt marks observed on the cable at positive terminal. Brush assembly cover is opened and the brush holders and brush assembly found overheated and burnt. The carbon deposit was not found indicating that the armature was in standstill condition and not rotating. Condition of brushes found in good condition.

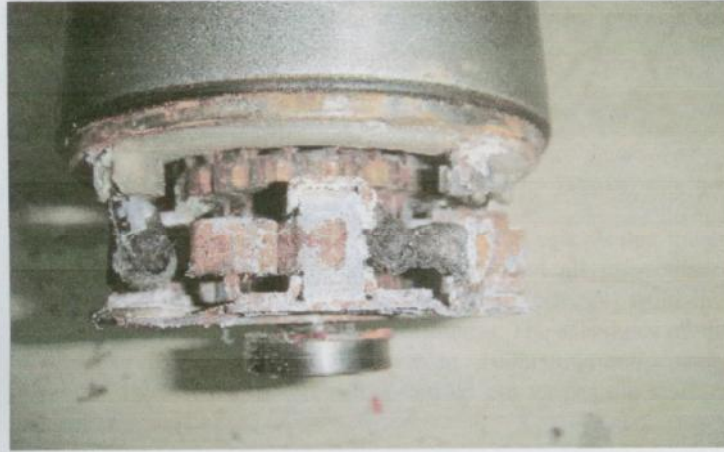
On the basis of the shop findings it was concluded that the Starter has drawn very high current in standstill condition leading to armature burnt at the point of contact of brushes. The cable connecting to positive terminal of Starter to Brush assembly found overheated but the sleeve over the cable did not burn. Overheat marks observed on cable connecting Starter and Contactor X61-0027. The lug on contactor terminal (external & internal) found blackened. This indicates the failure of Starter.

Secondly, the pull force of the contactor plunger is not sufficient to close the contacts properly hence can give rise to excessive heat at contacts due to heavy current demand from Starter.

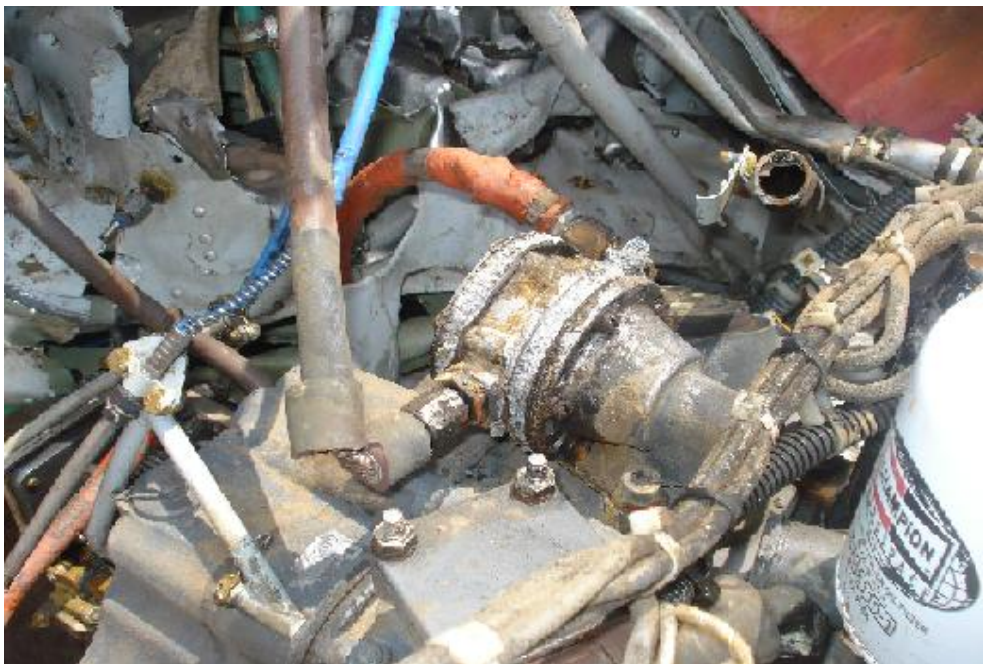
FUEL DISTRIBUTION VALVE WITH BURN MARK

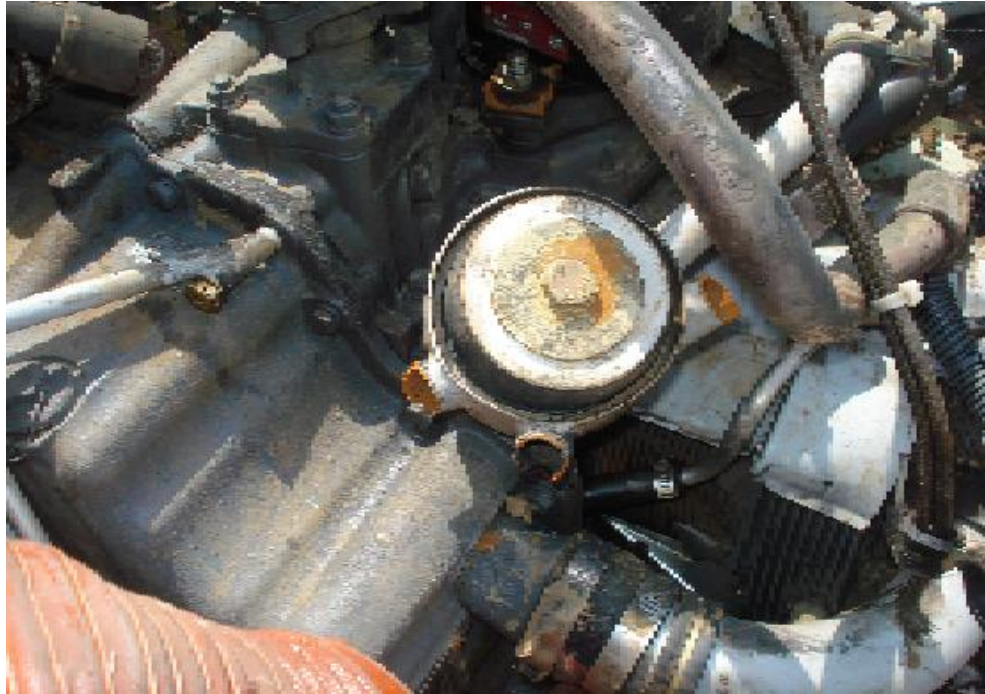
BLACK SOOT ON EXHAUST & ON ENGINE

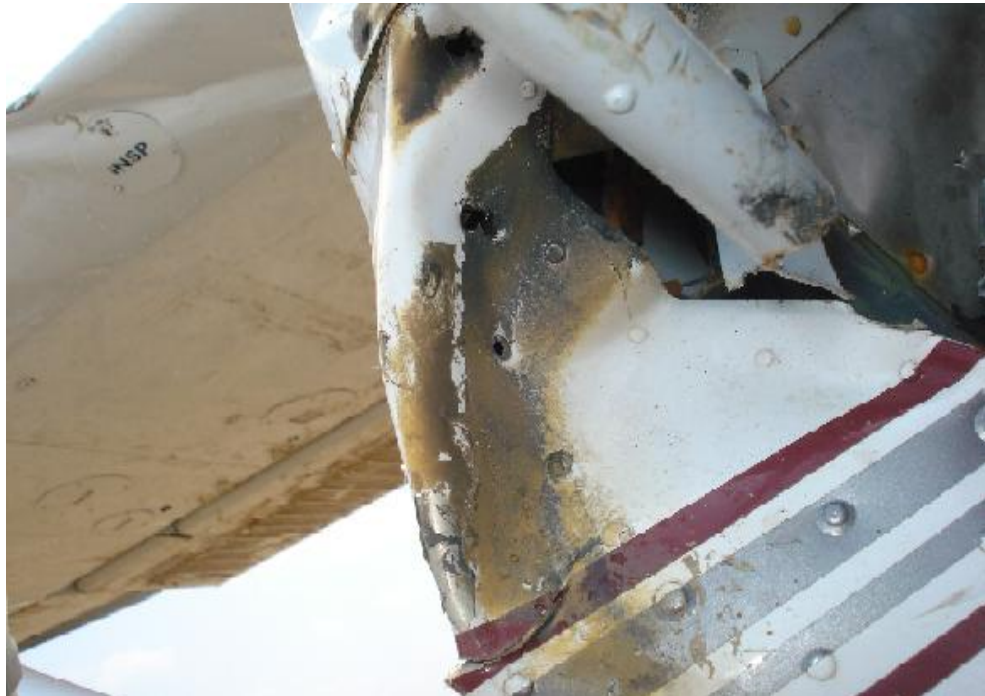
There was no post impact fire as the aircraft had immediately got completely submerge into water. However the fire wall top portion is seen completely blacken due to soot it seem there was superficial fire .

BLACK SOOT VISIBLE

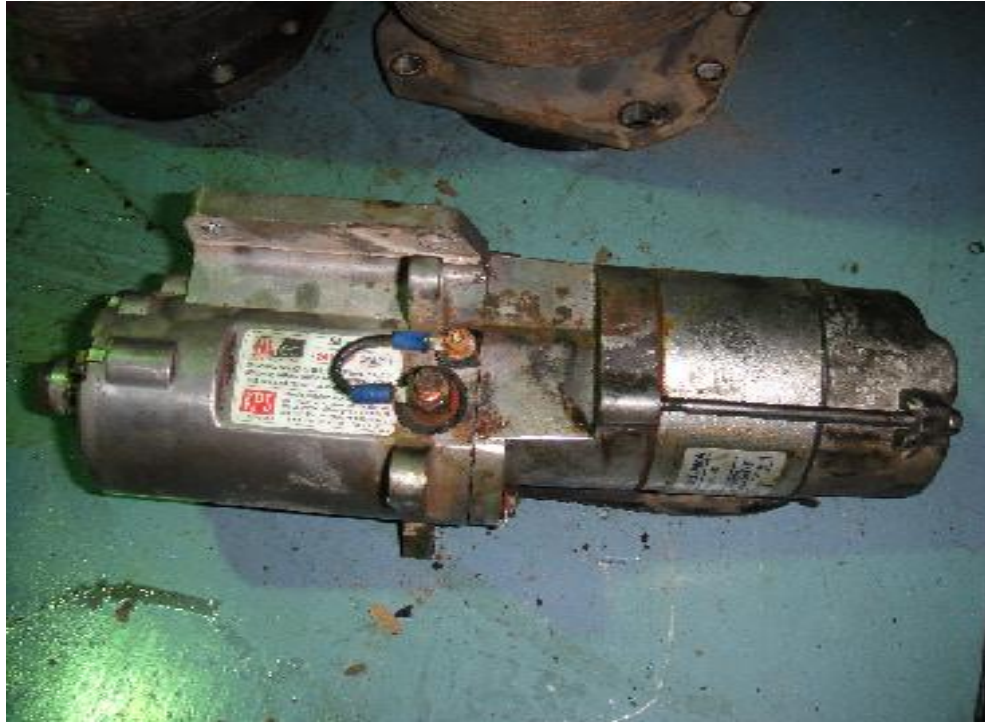
On the basis of the shop findings it was concluded that the Starter has drawn very high current in standstill condition leading to armature burnt at the point of contact of brushes. The cable connecting to positive terminal of Starter to Brush assembly found overheated but the sleeve over the cable did not burn. Overheat marks observed on cable connecting Starter and

Contactors X61-0027. The lug on contactor terminal (external & internal) found blackened. This indicates the failure of Starter.

STARTER SHOWING SIGN OF OVERHEAT

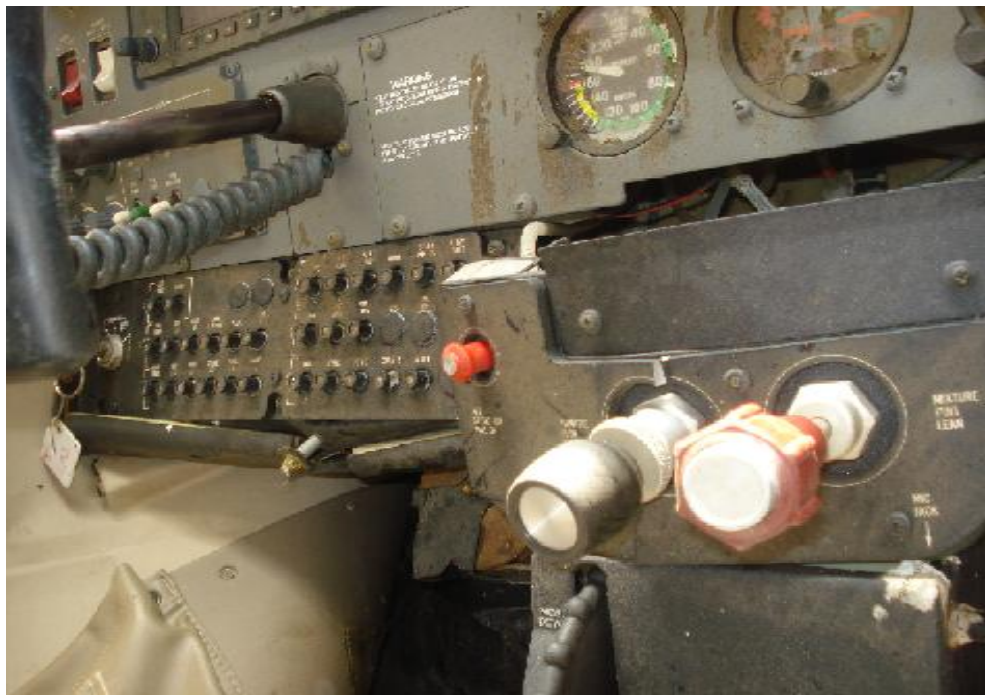
THROTTLE FULL & MIXTURE LEAN, KEY ON BOTH(MAG)
