CONNECTION TO OLDER RECEIVERS SUCH AS COLLINS 51R8, 51RV-1, KING KNR660 AND SIMILAR RECEIVERS. SEE NOTE 1.

## ARINC NAV RECEIVERS KNR634 AND COLLINS VIR-30A (FOR VIR-30M SEE ABOVE) SEE NOTE 2.

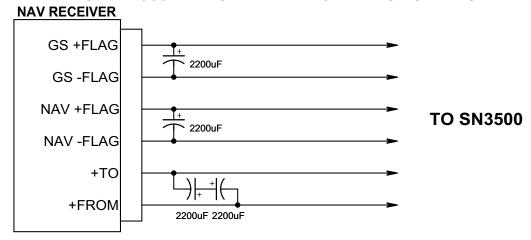
- 1. THE SN3500 REQUIRES DC FLAG SIGNALS. SOME VERY OLD RECEIVER DESIGNS OUTPUT UNSMOOTHED DC DUE TO A LACK OF FILTERING CAPACITORS. THE SN3500 WILL SHOW UNSTABLE FLAG OPERATION UNLESS SMOOTHING CAPACITORS ARE ADDED AS SHOWN. THE CAPACITORS CAN BE MOUNTED ON A TERMINAL BLOCK NEAR THE RECEIVERS. CONSULT THE RECEIVER SERVICE MANUAL SCHEMATICS AS REQUIRED.
- 2. FOR ARINC NAV RECEIVER USING 400HZ DIFFERENTIAL RESOLVER:
- a) THE NAV RCVR AND SN3500 MUST BE ON THE SAME INVERTER.
  b) ON OBS/RELAY/CDI MAINTENANCE PAGE SET OBS TYPE TO

United LXF10VB222M or equivalent.
