CONNECTION TO OLDER RECEIVERS SUCH AS COLLINS 51R8, 51RV-1, KING KNR660 AND SIMILAR RECEIVERS. SEE NOTE 1.

## ARINC NAV RECEIVERS KNR634 AND COLLINS VIR-30A (FOR VIR-30M SEE ABOVE) SEE NOTE 2.

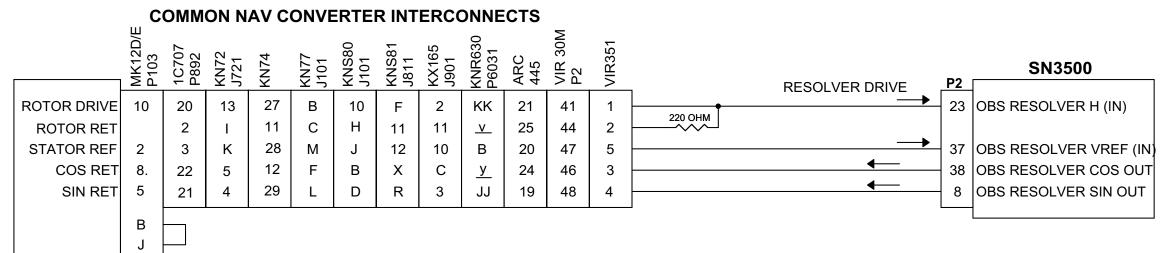
- 1. THE SN3500 REQUIRES DC FLAG SIGNALS. SOME VERY OLD RECEIVER DESIGNS OUTPUT UNSMOOTHED DC DUE TO A LACK OF FILTERING CAPACITORS. THE SN3500 WILL SHOW UNSTABLE FLAG OPERATION UNLESS SMOOTHING CAPACITORS ARE ADDED AS SHOWN. THE CAPACITORS CAN BE MOUNTED ON A TERMINAL BLOCK NEAR THE RECEIVERS. CONSULT THE RECEIVER SERVICE MANUAL SCHEMATICS AS REQUIRED.
- 2. FOR ARINC NAV RECEIVER USING 400HZ DIFFERENTIAL RESOLVER:
- a) THE NAV RCVR AND SN3500 MUST BE ON THE SAME INVERTER.
  b) ON OBS/RELAY/CDI MAINTENANCE PAGE SET OBS TYPE TO
